### PRODUCT INFORMATION BULLETIN Jan. 29, 2004

#### PRODUCT: TRIPLINES APPLICATION: ALL STANDARD VALVE BAMBI BUCKET MODELS PURPOSE: PRODUCT INFORMATION REGARDING NEW TRIPLINE DESIGN Applicable Tripline Part Numbers: Models 6072, 8096, 9011, 1012, 1214, 1518, 1821 - BB380 Models 2024, 2732, 3542, 4453 - BB386 Models 5566, 5870, 6578, 7590 - BB387 Models HL5000, HL7600, HL9800 - BB390

### Technical Bulletin Bambi Bucket 2024 Short Line Conversion Kit Instructions May 12, 2005

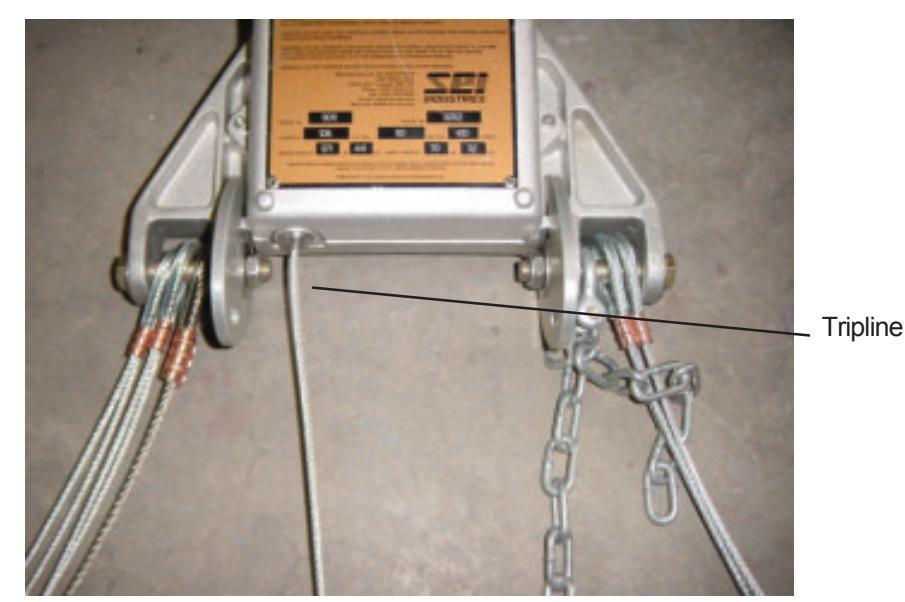
New tripline installed in Control Head. Lug Plates installed. **Note:** Control Heads built after January 2004 will not require Lug Plates.

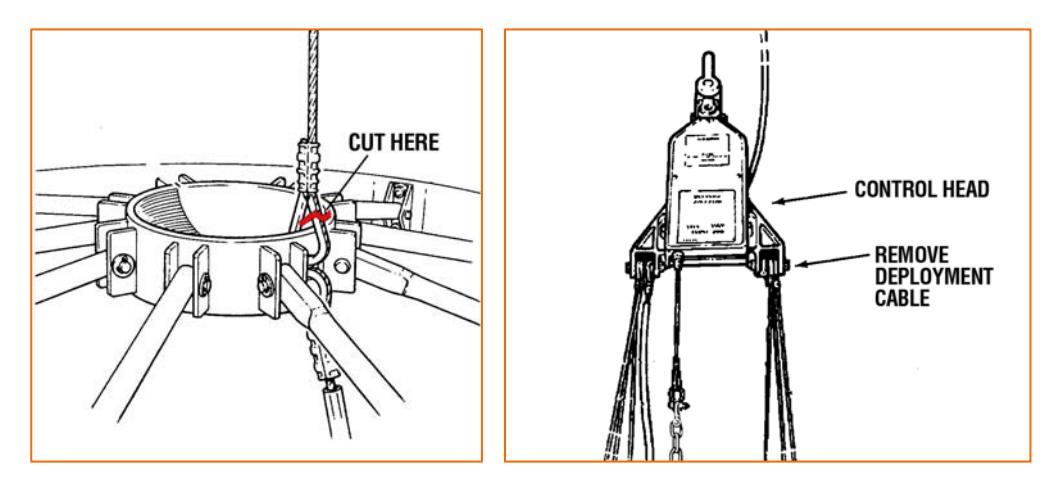
## DEPLOYMENT CABLE

- 1. Cut existing deployment cable off the hub by cutting through the cable/thimble loop swaged to the hub.
- 2. At the existing cable's opposite end, remove the suspension nut and bolt from the appropriate sleeve (ear) on the control head casting; you can now completely remove the cable.
- 3. Attach shackle end of the new deployment cable to the hub ring.
- 4. Insert the other end of the new deployment cable on the appropriate sleeve (ear) of the control head casting.

Note: Replacing the deployment cable should be done in conjunction with installing new suspension lines.

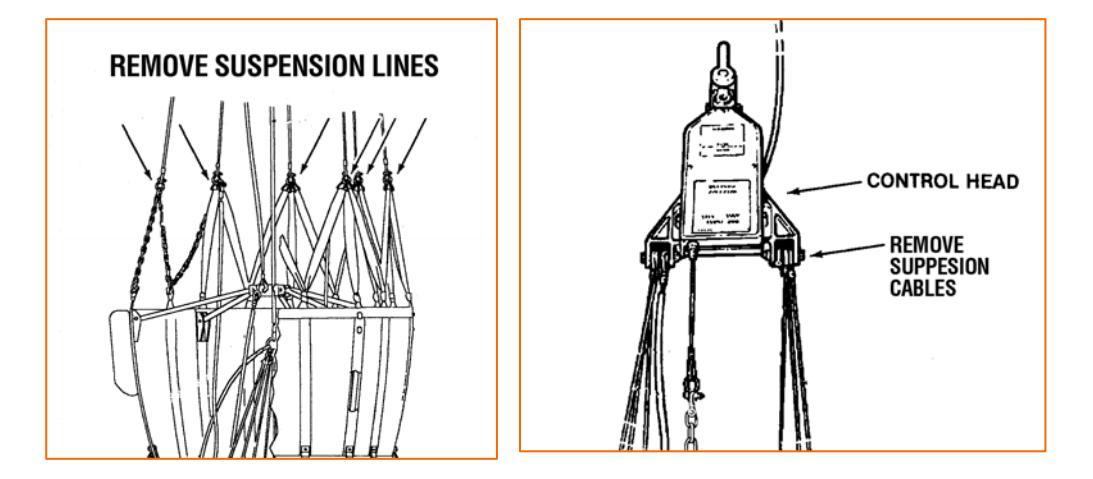
### SUSPENSION LINE SET

- 1. Remove the shackle pins from the shackles on the M-straps.
- 2. Remove the suspension lines, but be sure to note the order in which they were connected.
- 3. Remove the suspension nut and bolt from both sleeves (ears) on the control head casting.
- 4. Remove the suspension lines, again noting the order in which they were positioned.
- 5. Insert the new suspension lines into the control head sleeves (ears), making sure they are installed in the correct order.
- 6. Attach the opposite ends of the new lines to the M-strap shackles, again making sure they are fastened in the correct order.

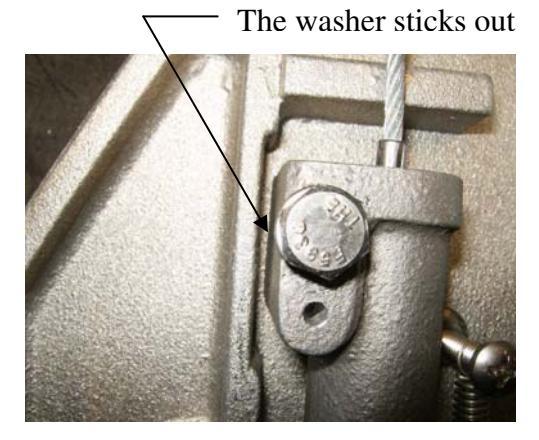
Photo #1

**Overview:** The hex head of the bolt used to attach the trip block to the control head can obstruct or impede the closure of the cover on the control head. When a washer is added to the trip block bolt or when the bolt is in a certain orientation, the washer or the hex head of the bolt sticks out (see photo #1 and #2), and can make contact with the cover, forcing the cover to move toward the left hand side of the head. The movement of the cover causes a misalignment of the bolt holes on the cover and the bolt holes on the control head. This misalignment prevents the bolts from entering the holes.

- The Hex head sticks out

- 1. If there are any washers remove them.
- 2. Rotate the trip block bolt until its hex head does not stick out (see photo #3), or change the hex head bolt to a socket head bolt. With the socket head bolt, it will not stick out in any orientation (see photo #4).

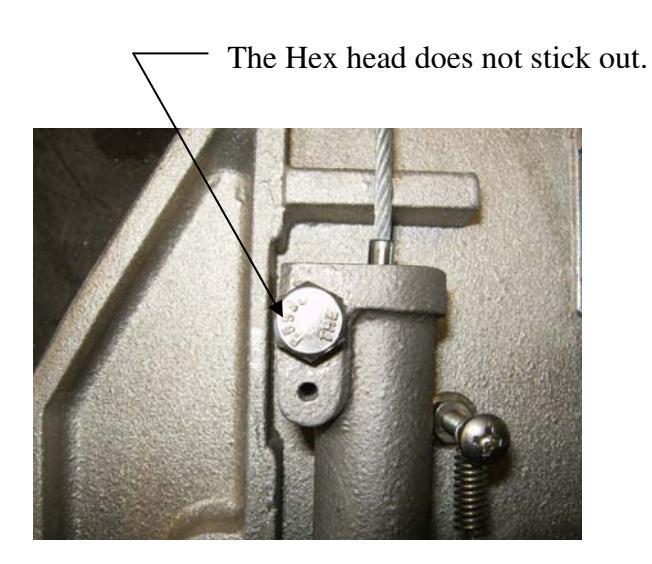
Photo #3

- The socket head does not stick out

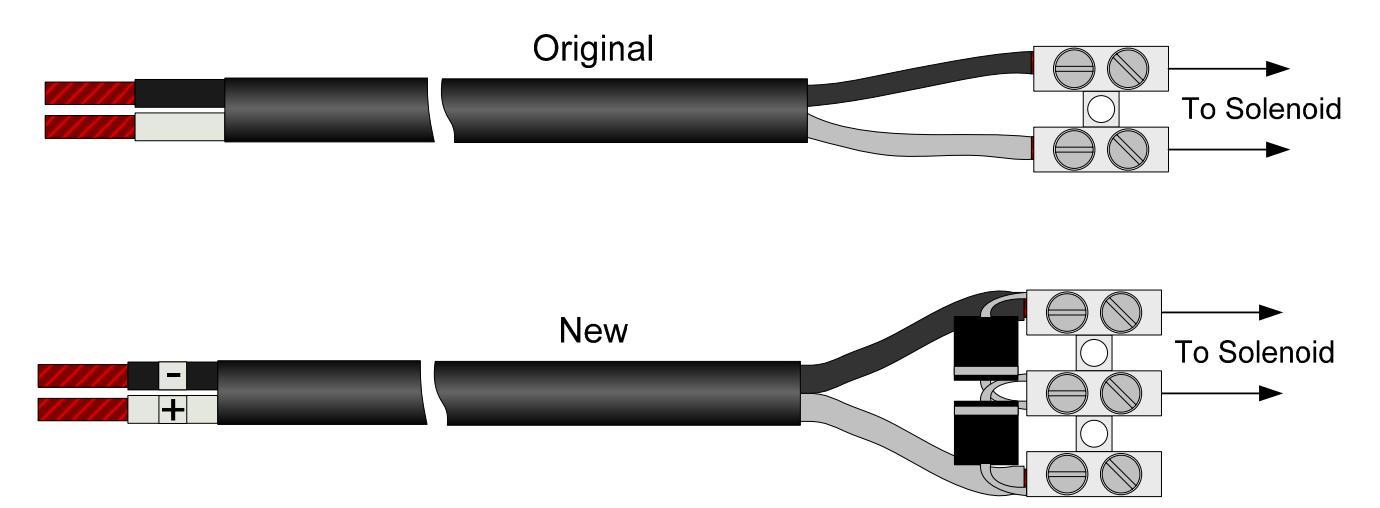
The new head lead wire design is identifiable by the addition of polarity markers on the white (+) and black (-) wires. Note that these polarities must be observed in order for the bucket to function.

Field replacement of an unpolarized head lead wire with a new-design head lead wire is accomplished by removing the existing wire and its 2-position wiring terminal from the head cavity and installing the new-design head lead wire in its place. The new-design head lead wire integrates a mounting bracket and a strain relief provision. Polarities are of no concern when connecting the solenoid wires, and no modifications to the head are necessary.

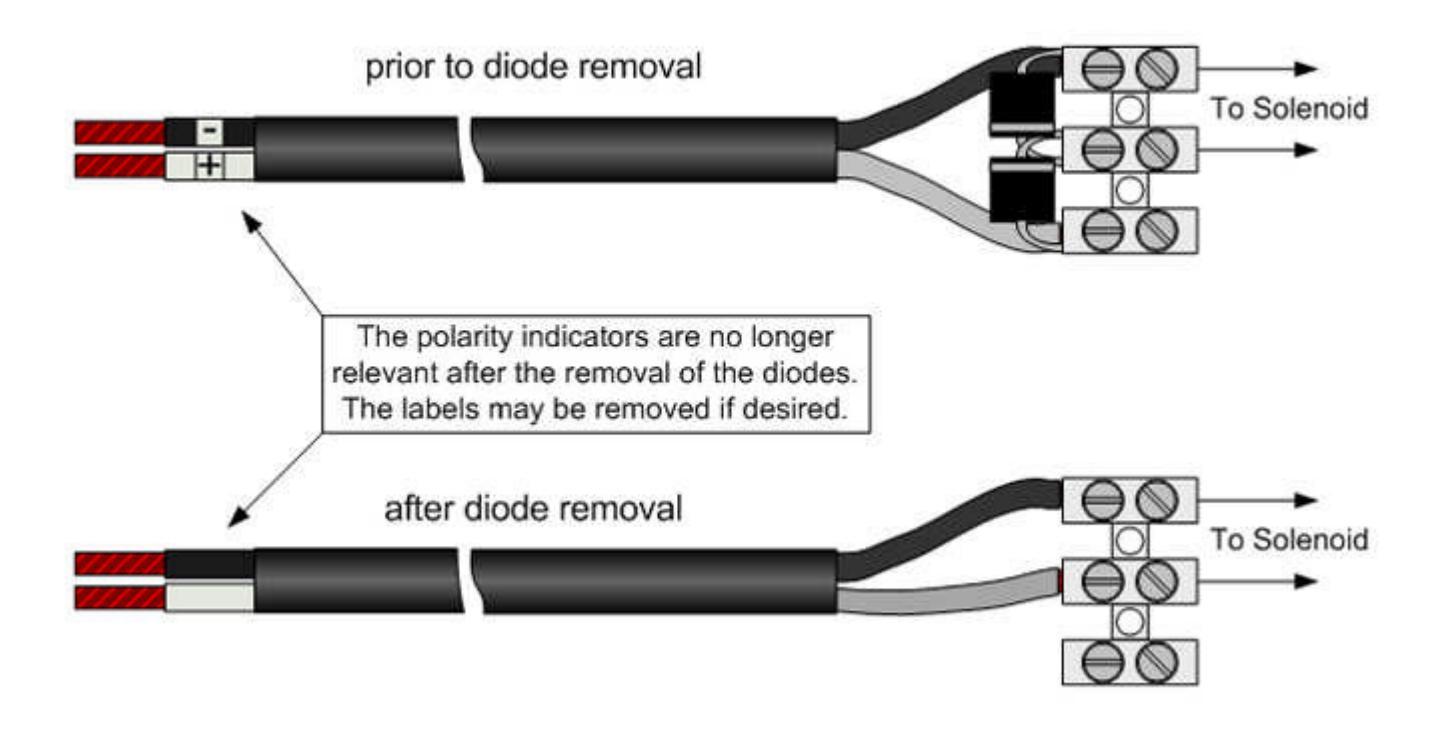
In response to customer feedback expressing concern with the potential for premature switch contact degradation of the dump release switch, on June 24, 2010 SEI incorporated a suppressor diode ("flyback diode") and a polarity protection diode into our head lead wires. For some customers this change resulted in operational complications, as the head lead wire polarity must be strictly observed. In the absence of hard evidence that dump switches are being impacted negatively, SEI has reverted to the original head lead wire design (no diodes) for all new buckets.

- b. cut their legs near the terminal body
- 1. Remove diodes
- 2. Relocate the white wire to the center terminal position, as shown in the illustration

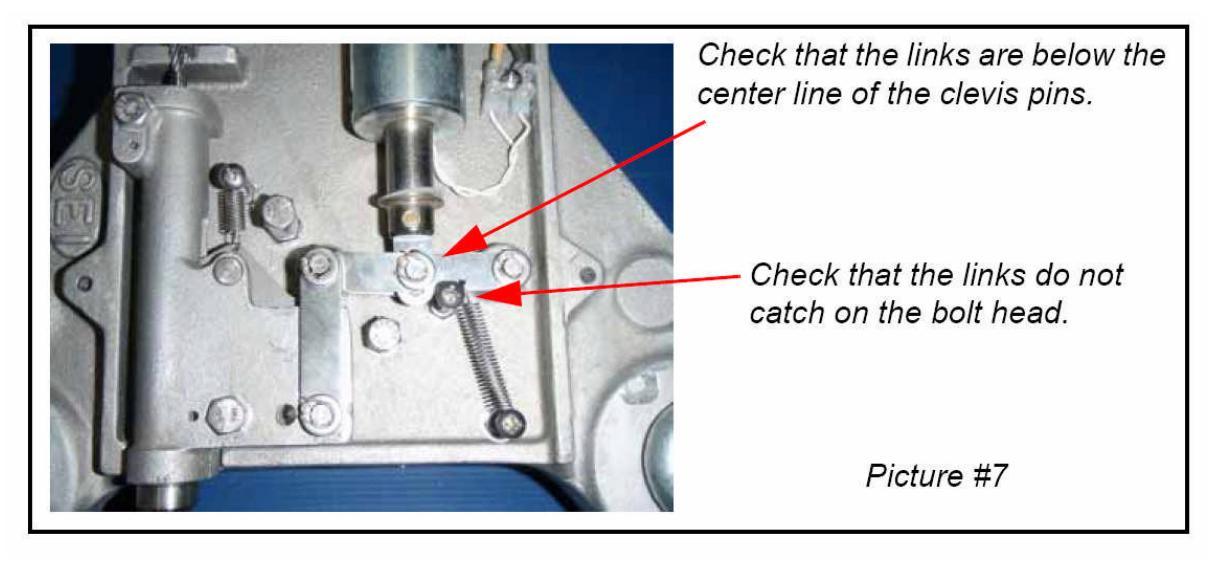
One of our customers had a problem in releasing a load in a standard valve Bambi Bucket. The valve did not operate in a consistent and regular manner. As part of SEI's ISO Quality Assurance program and following an internal engineering investigation, our senior production assembler identified that the screw shown on the attached photo was set too low.

The customer was informed to reset the screw height and has since solved the problem. Bambi engineering and firefighting division have created a customized gauge to allow Bambi Bucket production assembly staff to standardize the depth of the screw set. We are sharing this information with our sales representatives and service centers worldwide so that this problem can be both recognized with our customers and mitigated through troubleshooting in the event this is required.

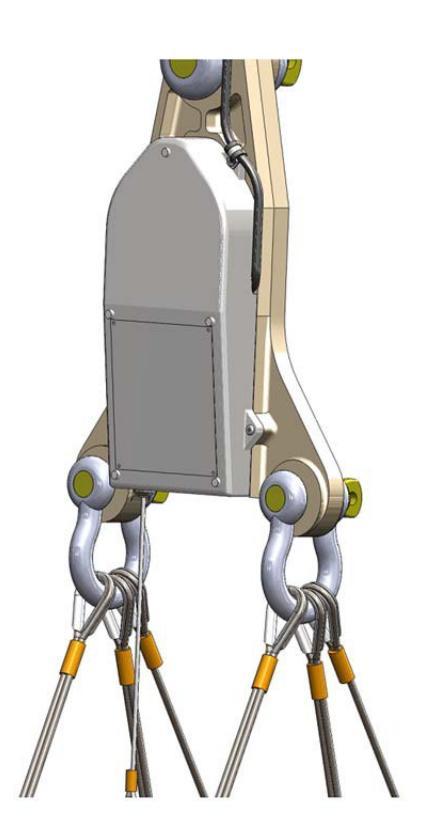
Figure 1 – Old Style (Order Half-Set Replacement)

If a suspension line on your Bambi Bucket is damaged or fails, it must be replaced. A suspension line displaying any noticeable kinking or fraying should be replaced. If your suspension lines are new models with links included, you should replace the damaged line individually. Individual lines come in singles and pairs depending on their position on the bucket. If your suspension lines have not been updated with links, replacement lines should still be ordered as a half-set. Refer to Figure and Figure for clarification.

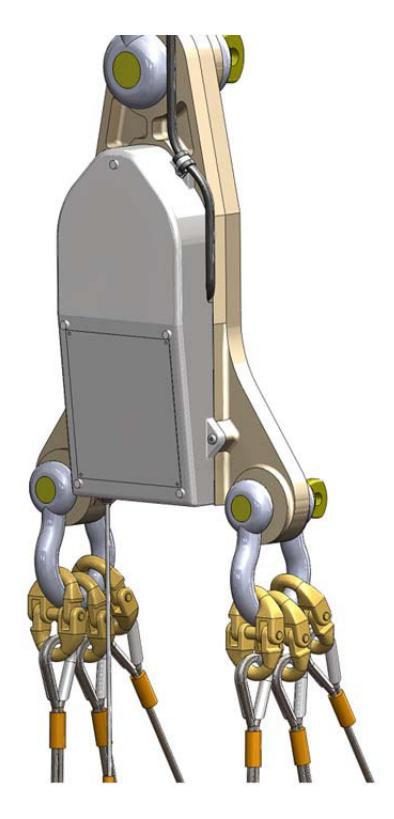
Figure 2 - New Style with Connecting Links (Order Single or Pair)

New suspension lines for 5566 buckets and larger will come with link connectors to allow for easy replacement of single suspension lines and pairs without replacing an entire half-set. The change also reduces the likelihood of the thimbles jamming on the lower control head shackles.

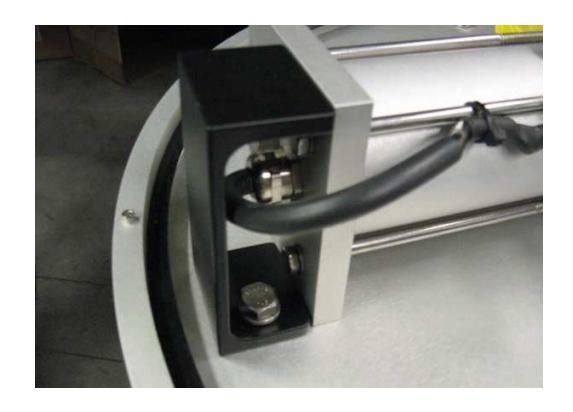
There have been multiple failures of Bambi MAX IVC's and actuators on the 25" valve. Investigation into the failures has identified the problem as damage to the electrical cable at the point it enters into the actuator. Water then enters the cable and migrates into the actuator and IVC causing a failure. The damage to the electrical cable is being caused by the IDS restrainer cable during deployment. In one case, the cable gland was torn off.

A cable guard has been added to protect the electrical cable and gland from damage. The guard mounts to the top plate of the valve using an existing bolt hole. The guard can be retrofitted in the field.

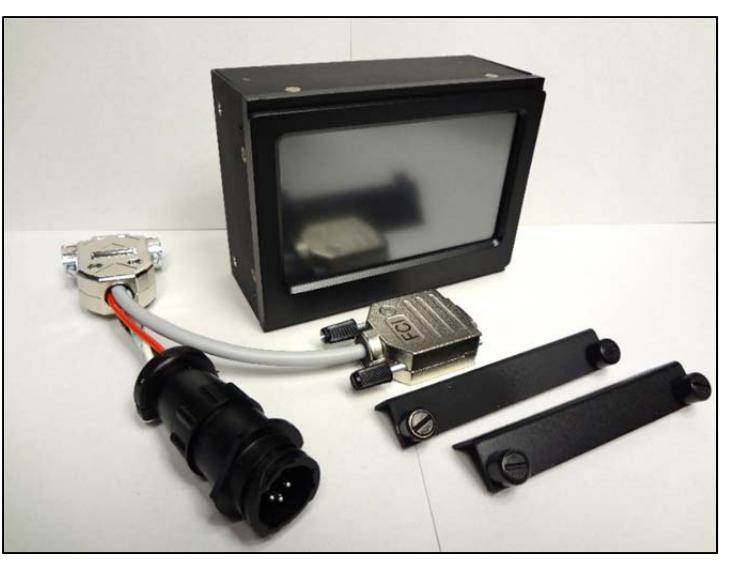
Figure 1 - SFC with DZUS mounts and Adapter

The SFC is operated with a glove compatible touch screen. The SFC includes an adapter that connects to the existing Sacksafoam wiring harness and includes a D-sub connector that can be used to connect with a remote injection switch. See Figure 2 for details.

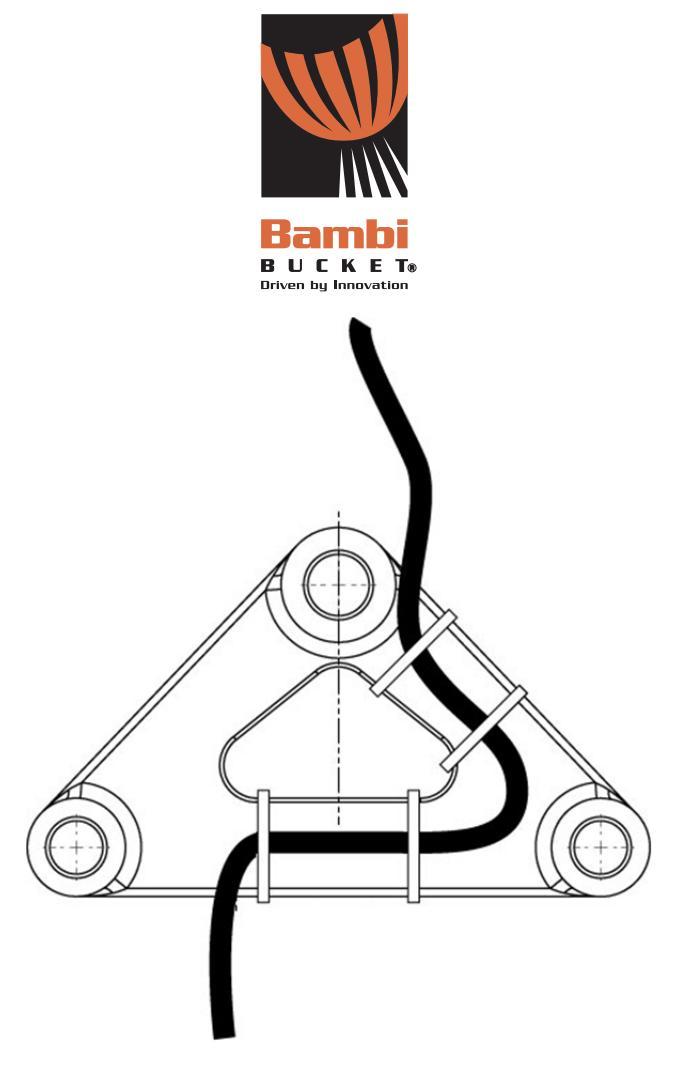
Figure 1 - Recommended Layout

Older Bambi Max manuals instruct operators to fasten the IVC power cable to the IDS hub and deployment cable using zip-ties. Operators are instructed to provide some slack during installation. Despite this, SEI has observed incidences of the power cable being pulled from the strain relief on the IVC, resulting in water ingress. The zip-tie may gradually work along the power cable over time and eliminate slack.

SEI recommends that operators avoid fastening the power cable to the IDS or IDS deployment cable all together. Instead the operators should fasten the cable directly to the bucket head with 4 zip-ties as illustrated in Figure 1. Operators must ensure that there is at least 6" of slack in the line. It is recommended that operators quickly check that there is adequate slack in the line before flight.

New buckets will already have the installation shown in Figure 1.

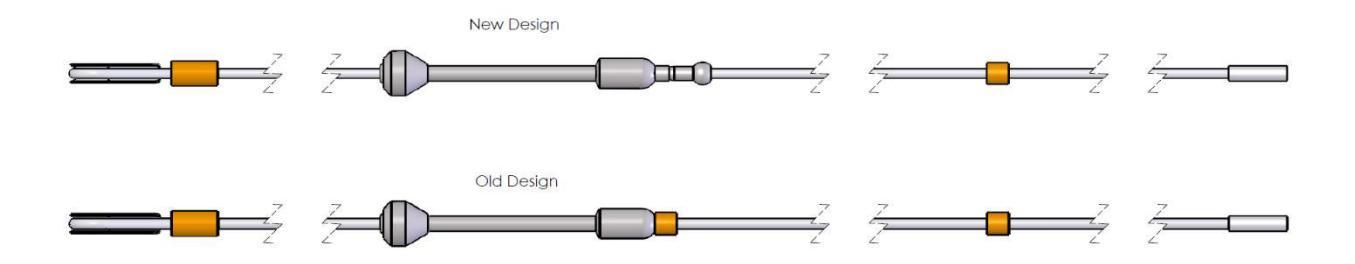
Since changing to stainless steel Triplines for the large Bambi buckets in 2015, multiple cases have been reported of the top stop swage on the bullet assembly failing. In all cases the swage slipped, and cause the bullet assembly to separate. This prevents the valve from resetting and allowing the bucket to hold water.

SEI is updating the design of the large Triplines (005333 & 005336) to eliminate this issue. The new design will feature a stainless steel ball swage and a spacer instead of the single copper swage at the top of the bullet assembly.

New Triplines from SEI will feature the new design. Due to the small number of reported incidents, SEI recommends that customers continue to use their Triplines with the old design if they are not experiencing issues with them.

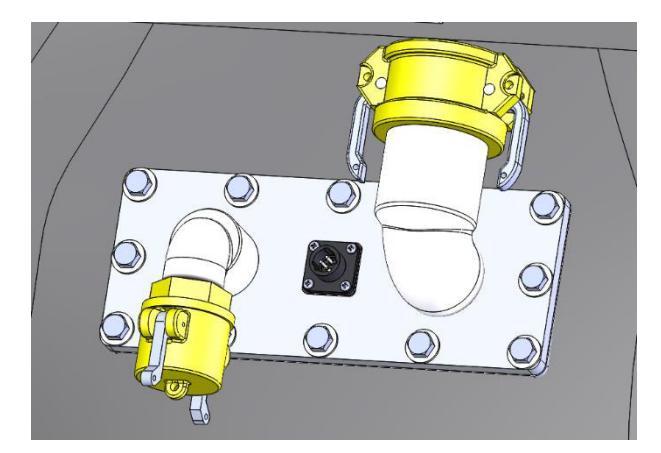
Figure 1- New Flange Design

Sacksafoam longline plug sets (001119) will also change to include waterproof NEMA 6-15 plugs.
